## **Submerged Reef Structures for Habitat Enhancement and Shoreline Erosion Abatement**

*by Lee E. Harris, Ph.D., P.E.*

**Purpose:** This Coastal Engineering Technical Note (CETN) presents the use of submerged artificial reef structures as submerged breakwaters, providing both wave attenuation for shoreline erosion abatement, as well as artificial reef structures for habitat enhancement. An example of this technology is presented for a project constructed using Reef Ball™ artificial reef units along the southern shore of the Dominican Republic near Bayahibe (east of Santo Domingo and LaRomano) during the summer 1998.

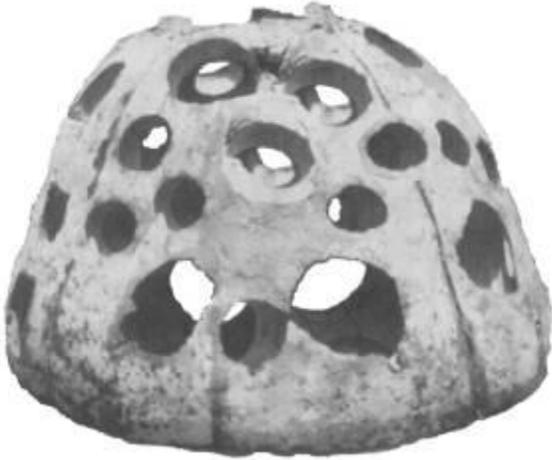
**Figure 1. Individual Reef Ball™ Unit.  
Deployment.**

**Introduction:** Approximately 450 Reef Ball™ artificial reef units were installed offshore of the Gran Dominicus Resort during the summer 1998 to form a submerged breakwater for shoreline stabilization, environmental enhancement and eco-tourism. The individual units used for the breakwater were 1.2m high Reef Ball units and 1.4m high Ultra Ball units, with base diameters of approximately 2 meters. Figure 1 shows an individual Reef Ball™ unit, and Figure 2 shows a photograph of the deployment, using large buoys inside and strapped to the Reef Ball units to float the individual units offshore and set them in place by divers.

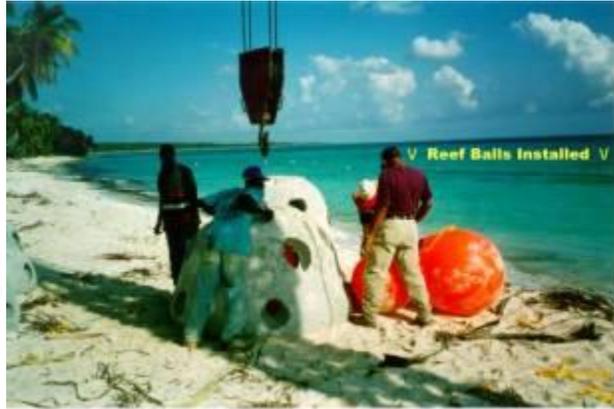
**Figure 2. Reef Ball**

**Project Design:** To obtain the highest individual unit weights possible, the Reef Balls were fabricated with the maximum volume of concrete for the molds, with each individual Reef Ball unit weighing approximately 6,000 pounds (2700 kg). To increase the strength and workability, plus decrease the pH of the concrete, microsilica and ADVA additives were used. Various sizes and weights of Reef Ball artificial reef units are available, as presented in Table 1.

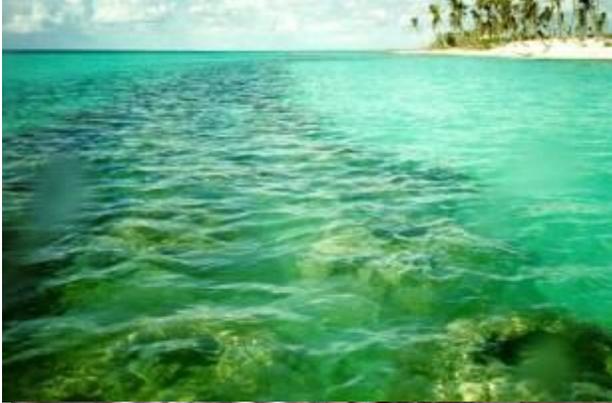
**Figure 3. Three-Row Submerged Breakwater.**

The design of the submerged breakwater system consisted of three segmented breakwater sections, using three rows of Reef Ball™ units for each segment (Figure 3 and 4). The breakwater was installed in water depths of 1.6m to 2.0m, so that the units were 0.2m to 0.8m below the mean water level (the tide range in the project area is approximately 0.4m).

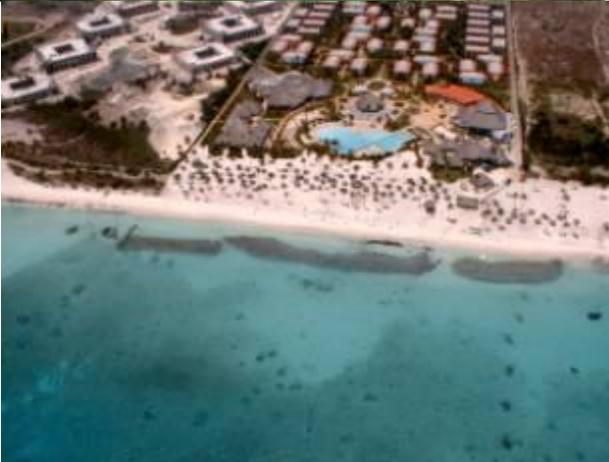
**Figure 4. April 2001 Aerial Photograph.**

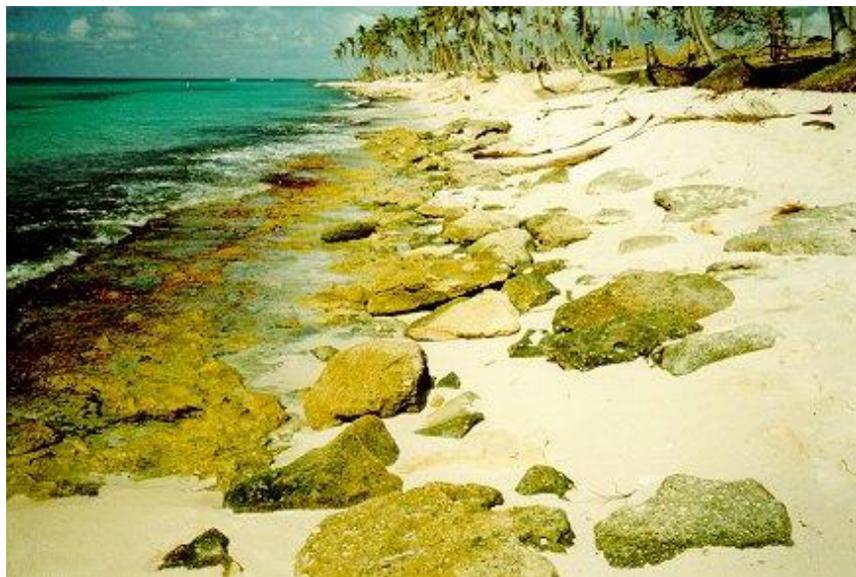
**Figure 5. Eroded Beach and Shoreline following Hurricane Georges and Mitch.**

**Shoreline Conditions after Hurricane Impacts:** Comparison of photographs taken before and after the installation of the Reef Ball artificial reef submerged breakwater show that sand had accreted and the beach was building prior to Hurricane Georges. The storm surge and wave conditions accompanying this category three hurricane greatly exceeded the levels for which the submerged breakwater can provide wave attenuation and shoreline protection, so that significant erosion of the beach and dune occurred, as shown in Figure 5.

A submerged breakwater becomes ineffective during severe storm surge conditions accompanying hurricanes. Hurricanes Georges and Mitch produced meteorological and oceanographic conditions that created elevated water levels due to the storm surge and waves. On top of this storm surge, the large waves and strong currents accompanying the hurricanes produced severe erosion of the shoreline, with large volumes of beach sand washed away, leaving a one to two meter high escarpment which undermined several palm trees in the project area and adjacent beaches to the east. The shoreline that had been sand prior to the hurricanes consisted of an exposed rock ledge.

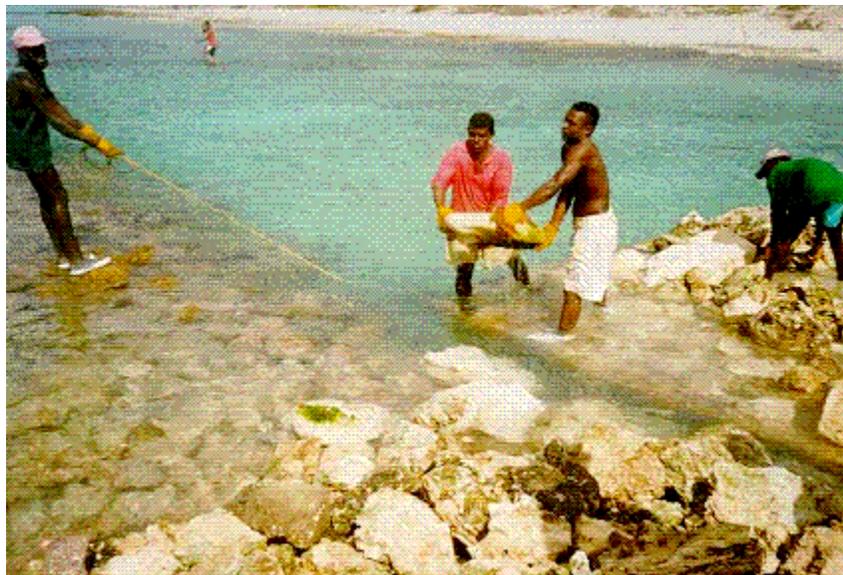
**Figure 6. Placement of smaller rocks on top of Reef Ball breakwater.**

Gran Dominicus added a small quantity of sand to the beach, and placed a considerable amount of small rocks seaward, landward, and on top of the submerged Reef Ball breakwater, as shown in Figure 6. This photograph shows that small rocks were used, instead of the larger rocks that would be stable under wave attack. In addition to widening and raising the elevation of the breakwater above the water level, rocks were added to connect the eastern end of the breakwater to the shore, as shown in Figure 7. Due to the use of the smaller rocks that were added to the breakwater, wave action easily displaced the rocks, scattering them landward of the original breakwater. Figures 8 and 9 show two aerial photographs that delineate the original Reef Ball breakwater from the scattered smaller rocks.

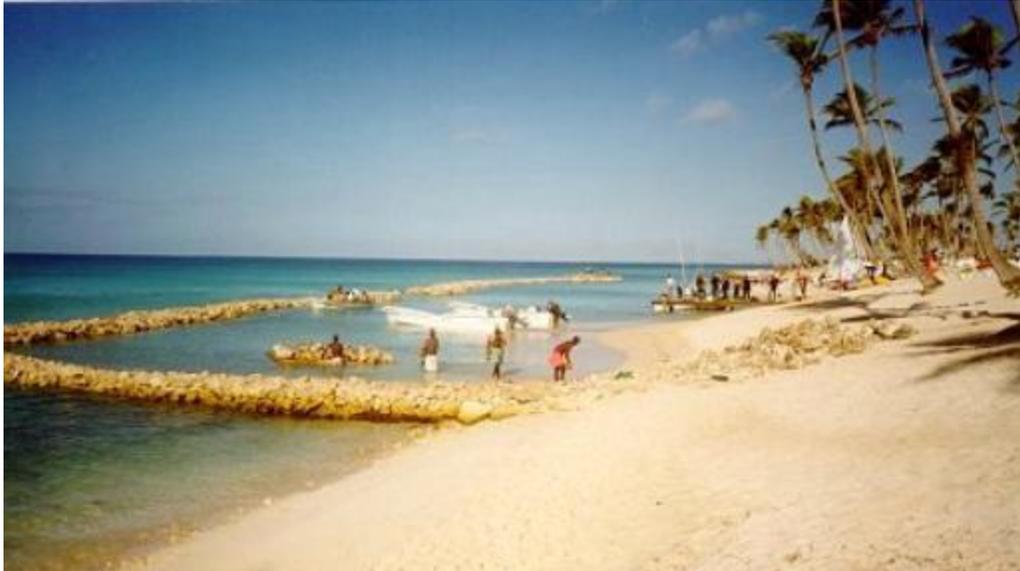
**Figure7. Rock placement on top of Reef Ball breakwater and connected to shore.**

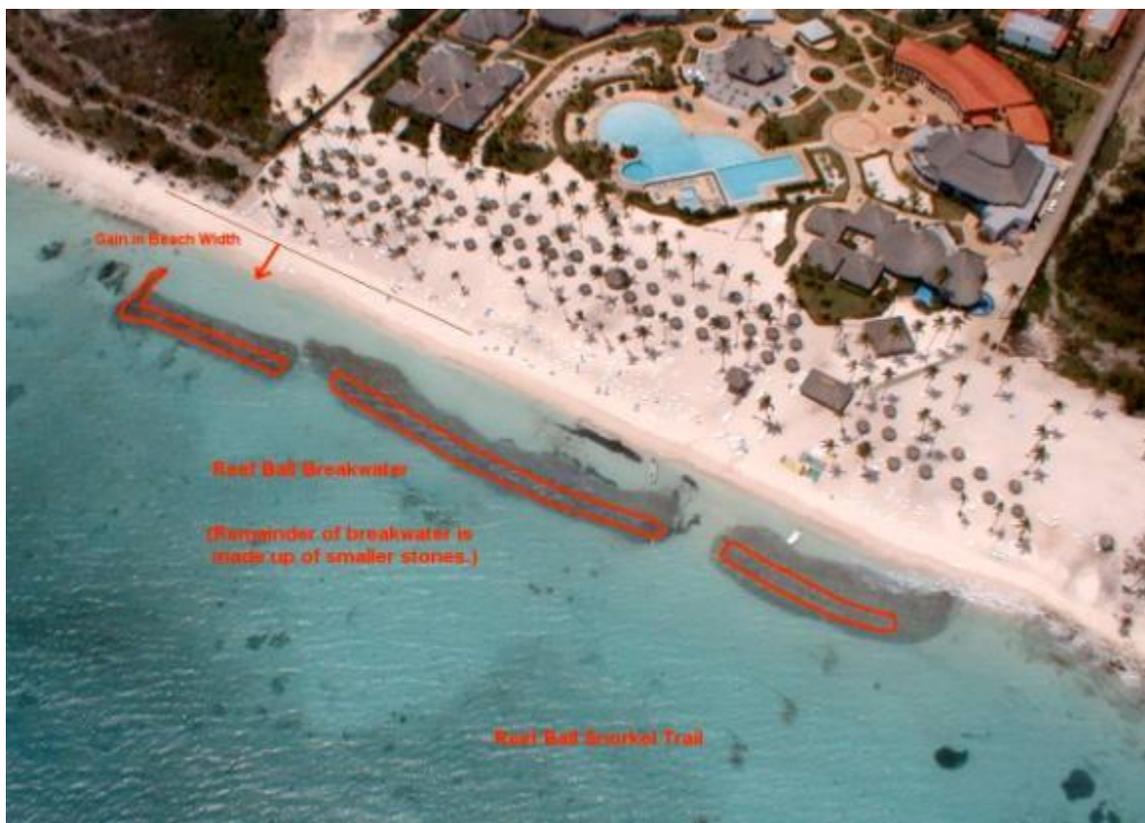
**Figure 8. Deliniation between the original Reef Ball breakwater and smaller rocks.**

Aerial photograph taken April 28, 2001.

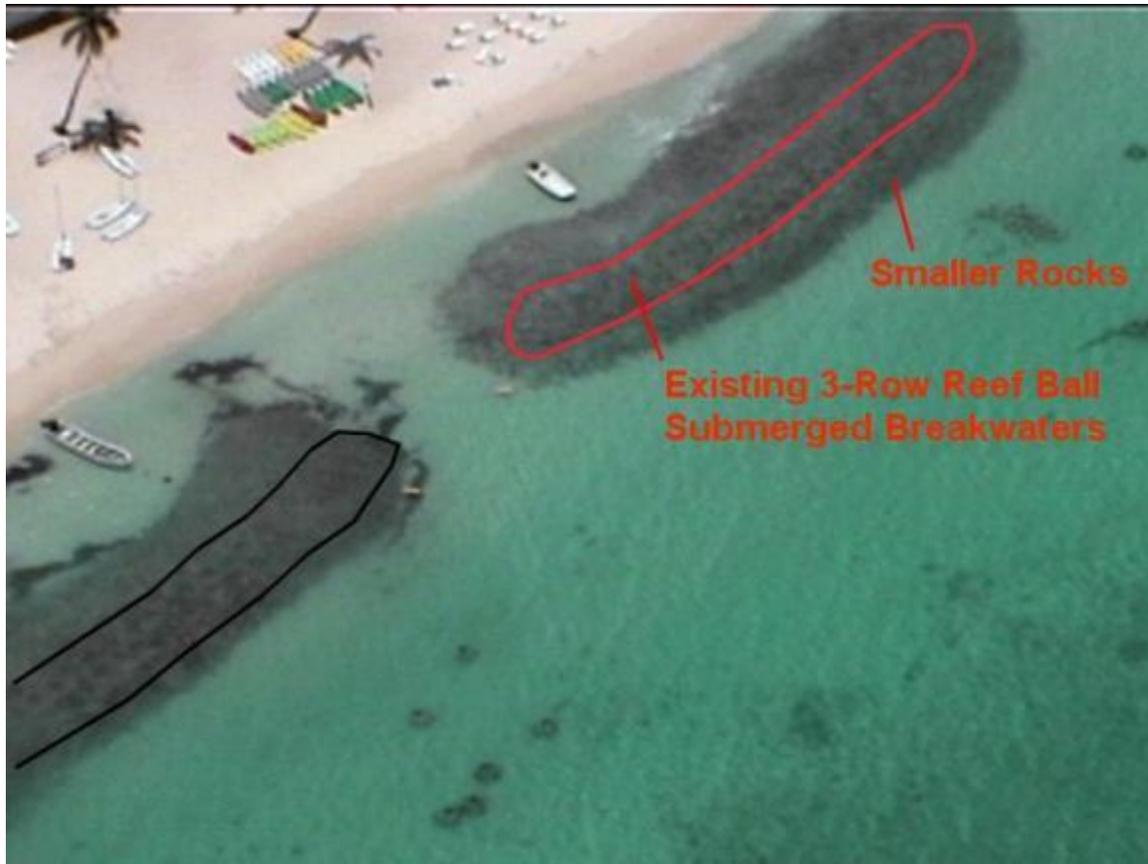
**Figure 8. Delineation between the original Reef Ball breakwater and smaller rocks.**

Aerial photograph taken April 28, 2001.

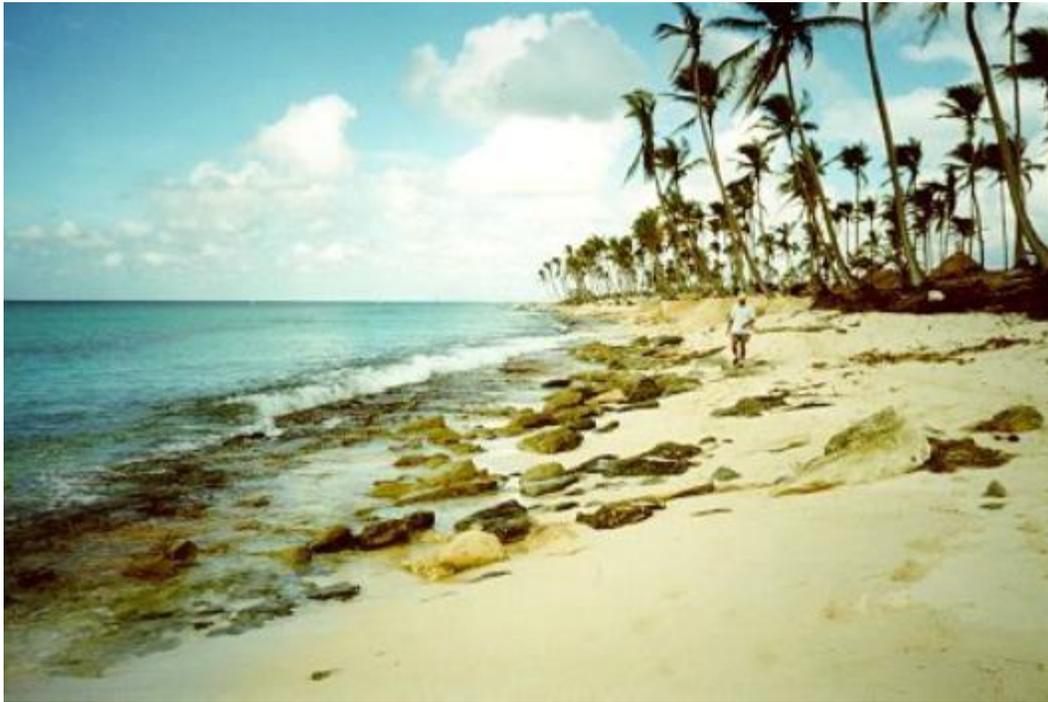
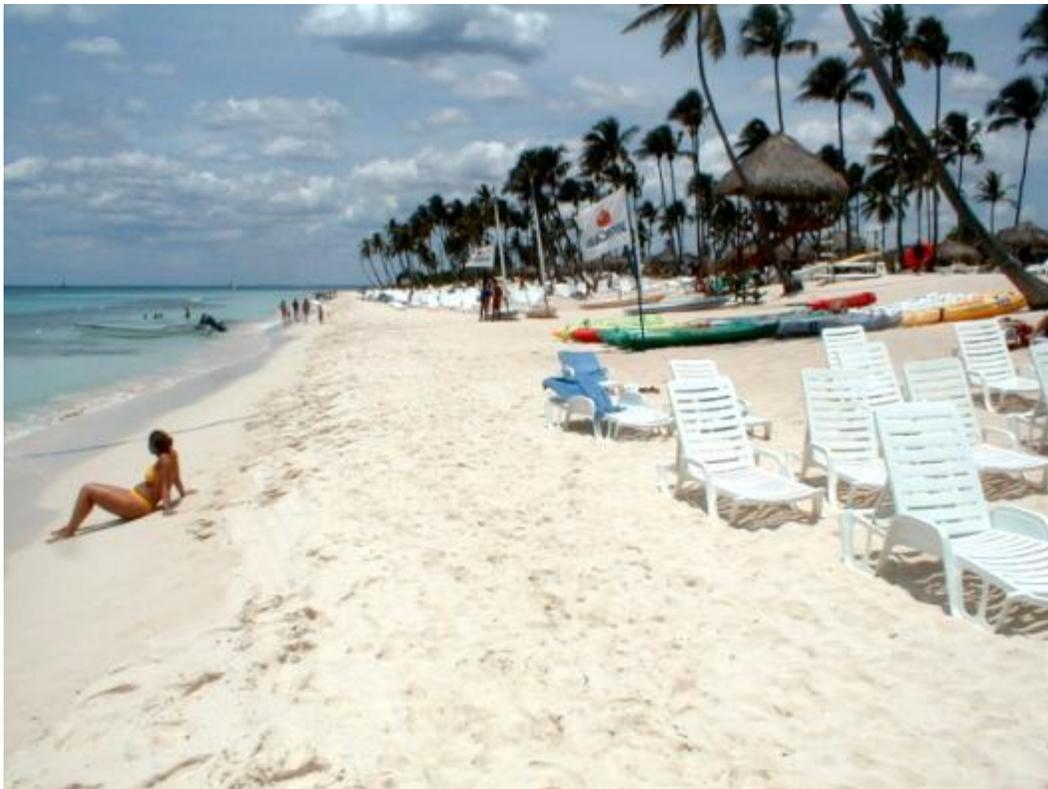
**Figure 9. Increased Beach Width at Gran Dominicus - looking west.**

November 1998 (top photo) compared with April 2001 (lower photo)

The comparison photographs in Figures 9 through 11 show that the Reef Ball breakwater has been very effective in assisting with the stabilization of the shoreline, with a significant increase in beach width and elevation along the Gran Dominicus shoreline. No adverse effects have occurred on adjacent beaches, as the beaches adjacent to the project have also accreted sand and recovered after the hurricanes in 1998, but not as much accretion as in the beach and shoreline area protected by the submerged artificial reef breakwater.

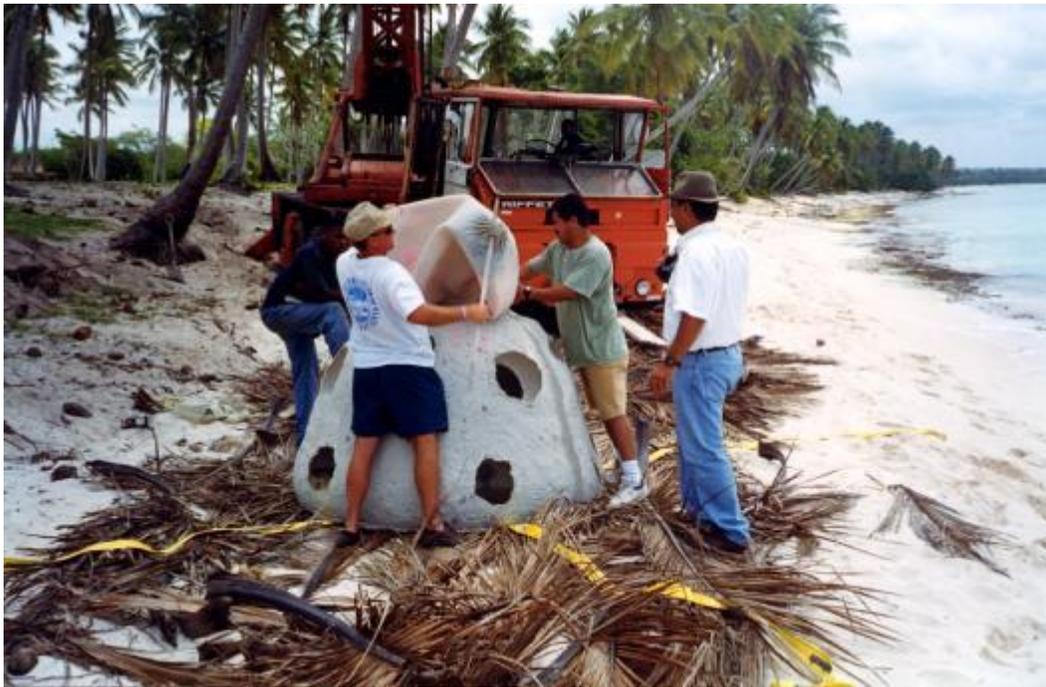
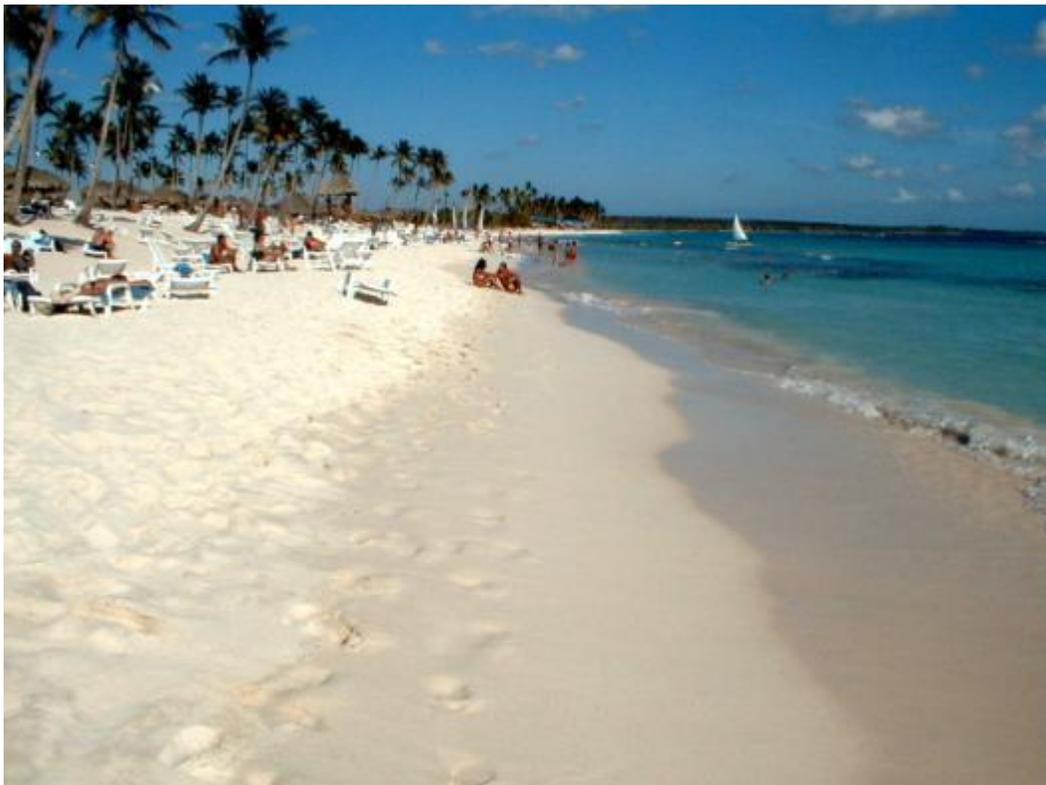
**Figure 10. Increased Beach Width at Gran Dominicus - looking east.**  
Summer 1998 (top photo) compared with April 2001 (lower photo)

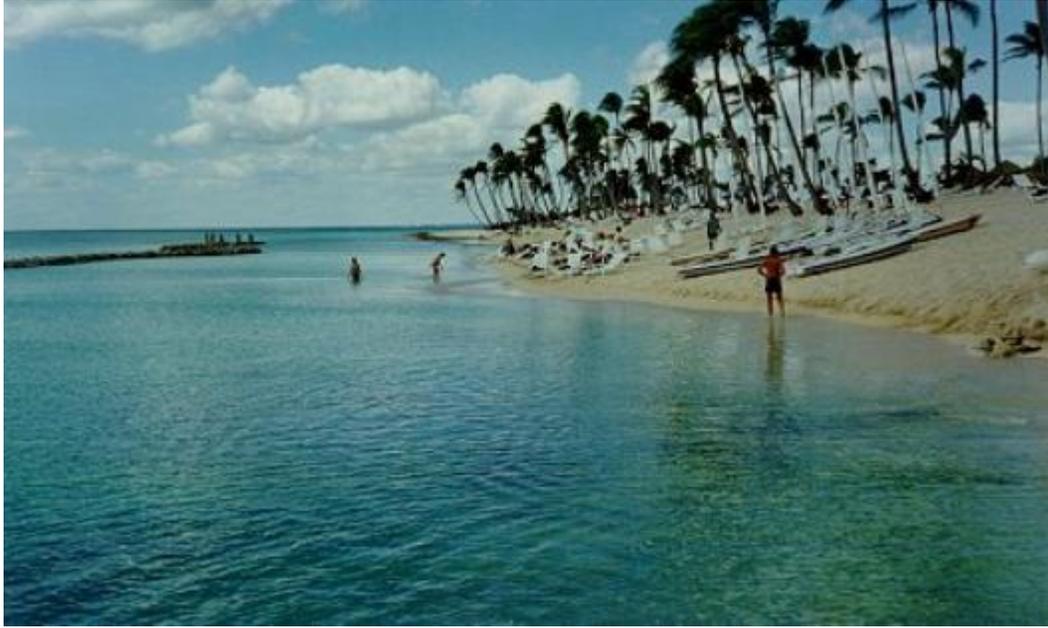
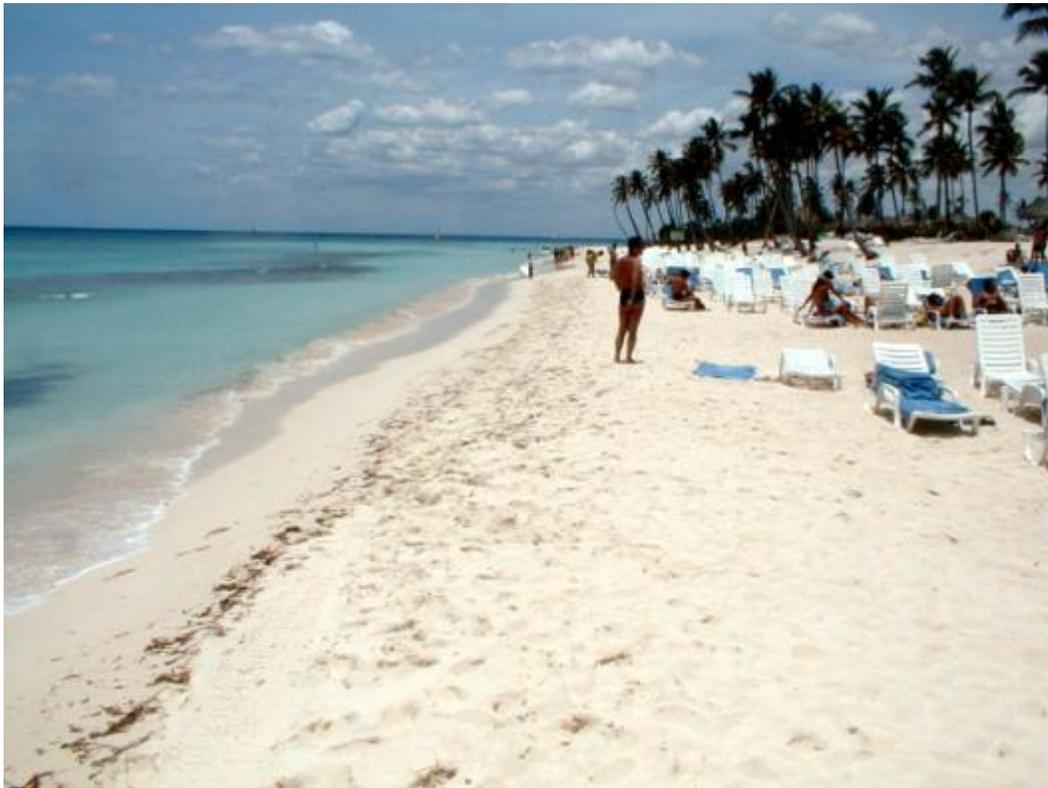
**Figure 11. Increased Beach Width at Gran Dominicus.**  
February 1999 after small rocks added on top of breakwater and sand fill (top photo),  
compared with April 2001 showing large natural accretion (lower photo).

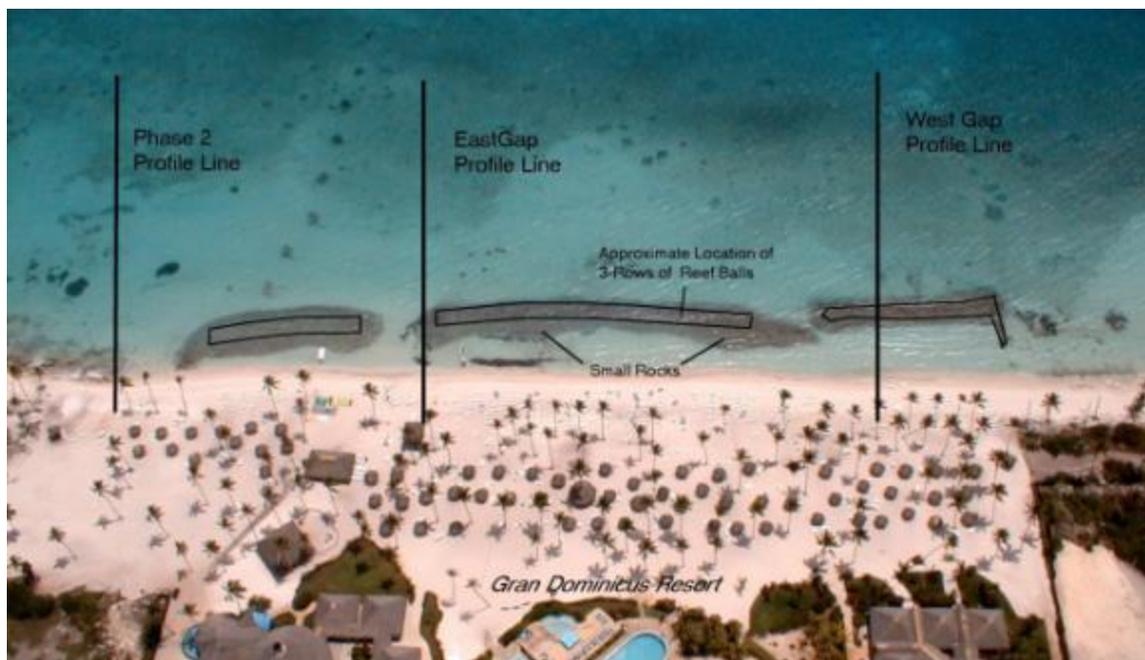
**Figure 12. Location of Survey Profile Lines**

The aerial photograph in Figure 12 shows the submerged Reef Ball™ breakwater and the locations of the survey profile lines. Figures 13 through 15 show graphs of the survey data comparing the beach profiles in February 1999 and April 2001.

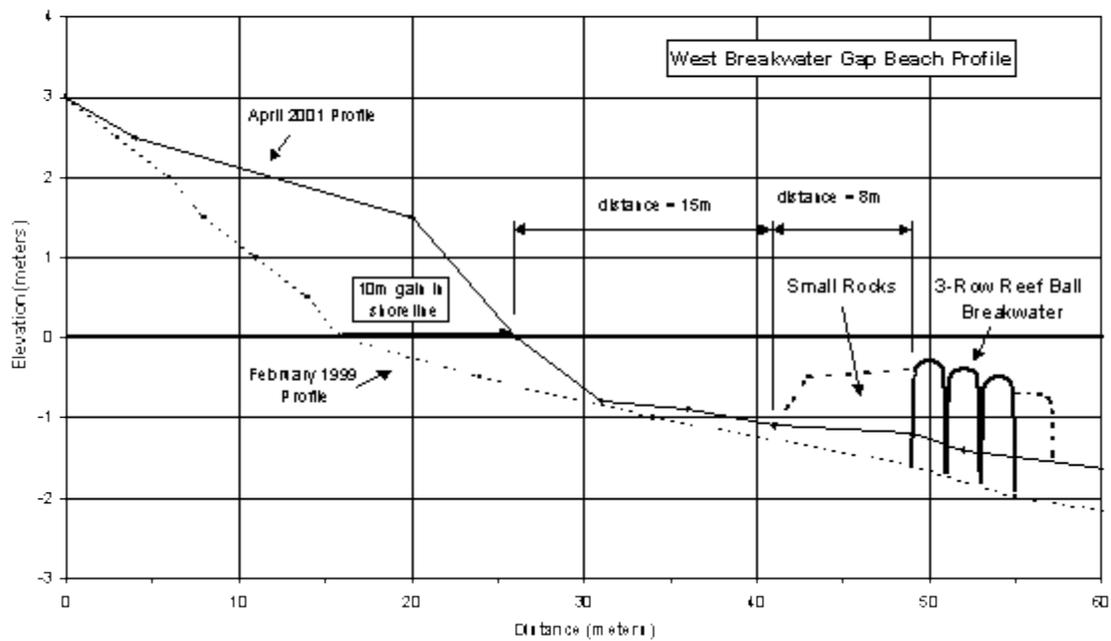
**Figure 13. Survey Profile across Breakwater at West Gap.**

The two graphs in Figures 13 and 14 clearly show sand accretion landward of the submerged breakwater system, with a 10m shoreline advance at the west end of the project and 13m shoreline advance at the east end of the project. Figure 15 shows the area immediately east of the project, where very little change in the amount of sand occurs. Comparisons between these three graphs in Figures 13 - 15 clearly show that the beach has gained a considerable amount of sand and the shoreline has advanced significantly in the project area, but has remained stable to slightly accretionary on the adjacent beaches.

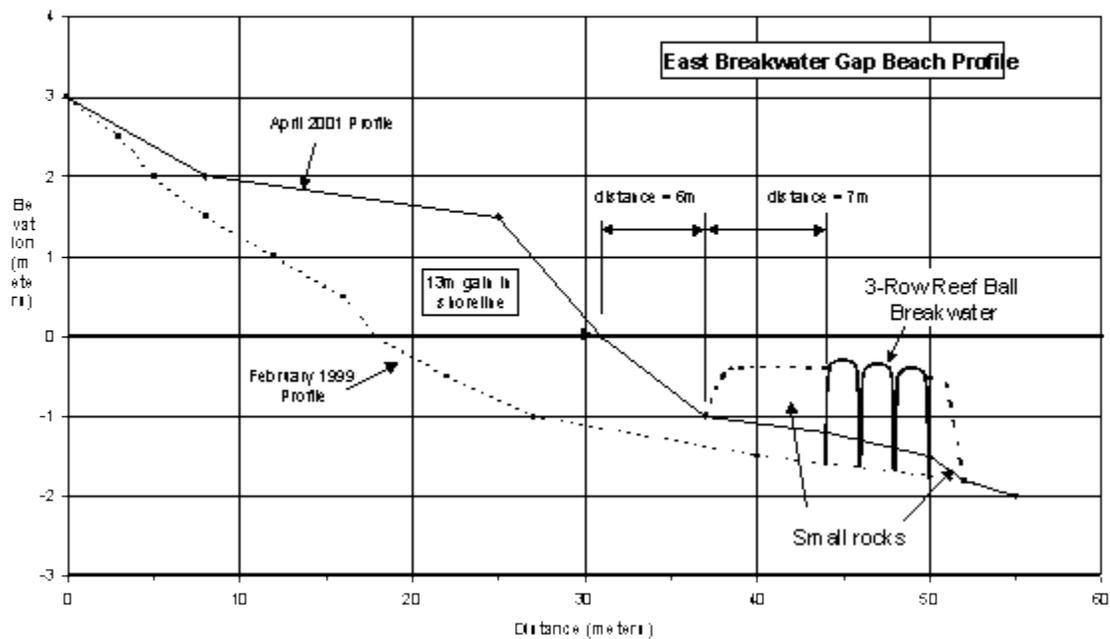
**Figure 14. Survey Profile across Breakwater at East Gap.**

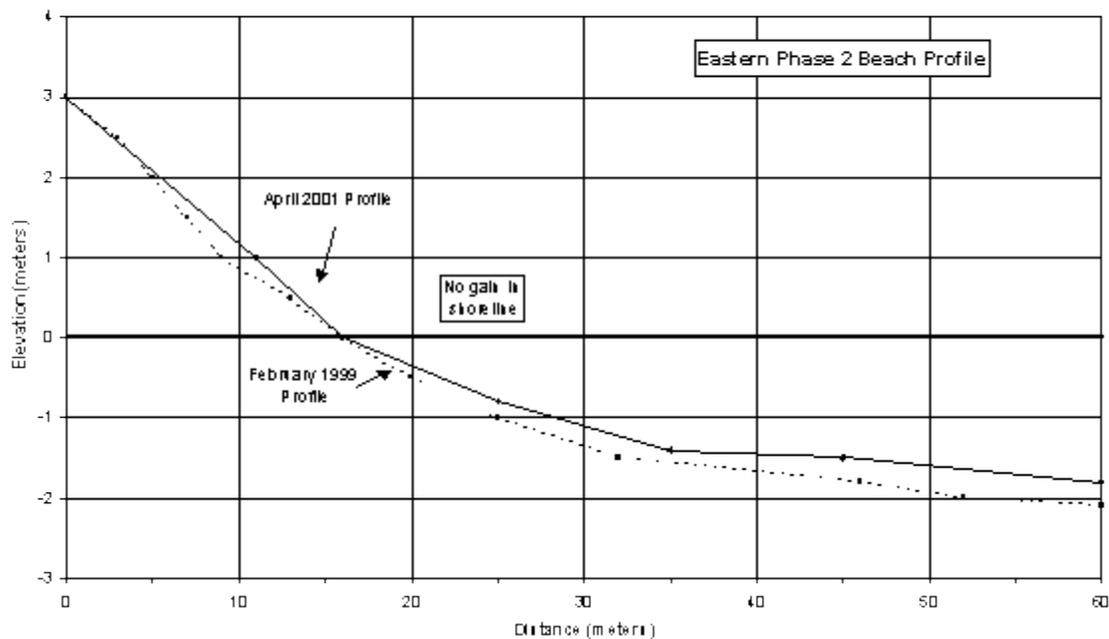
**Figure 15. Survey Profile East of Breakwater.**
