## **Reef Ball™ Designed Reefs Beaches, Turks and Caicos Final Report**

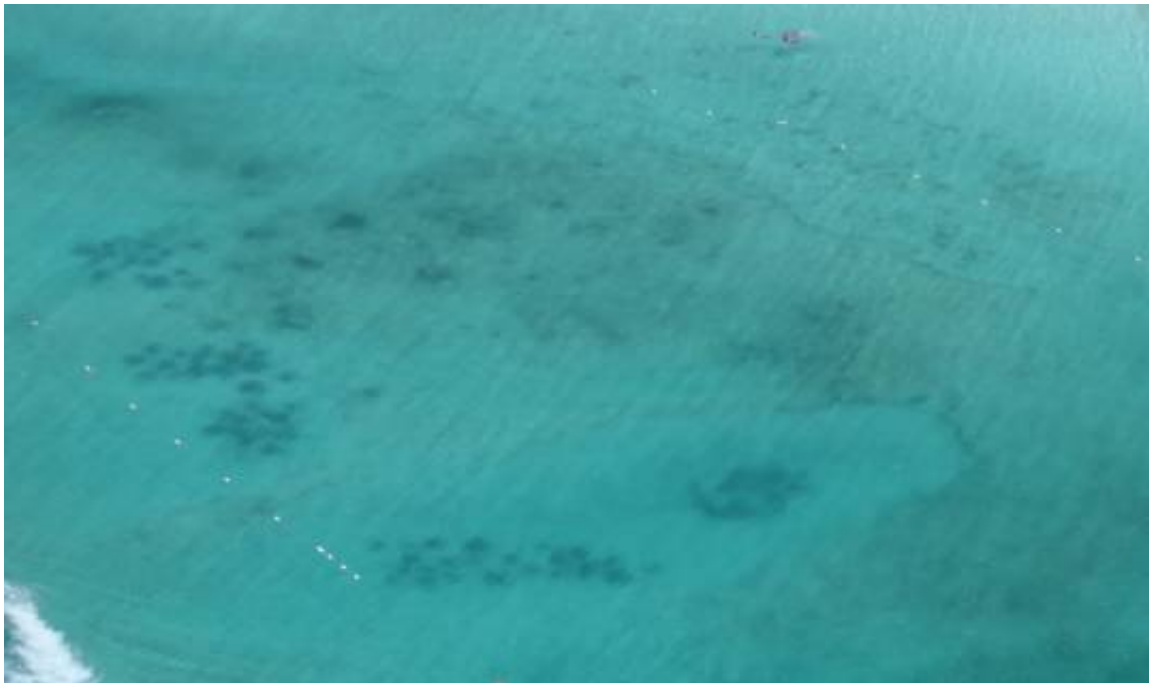
**Figure 1.**

**Aerial of site 1. Center of Beaches property**

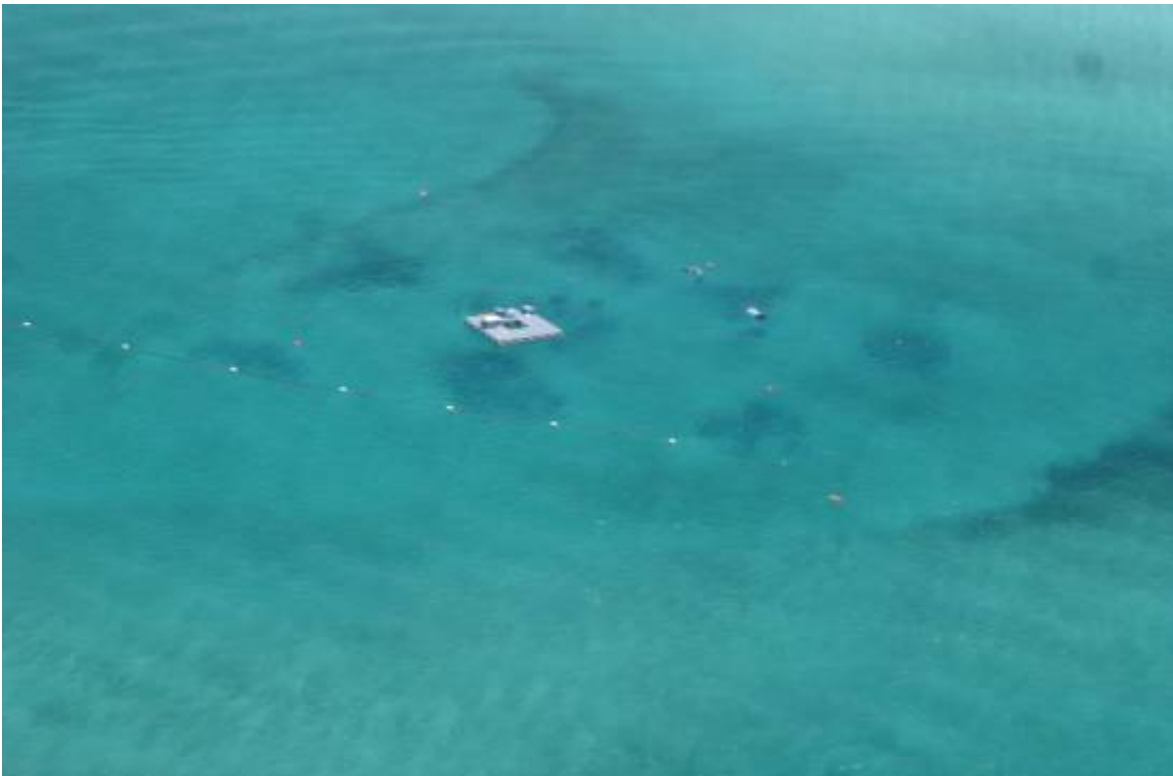
**Figure 2. Aerial of site 2. Located east of the dock. The floating platform is in the center of the surrounding pods.**

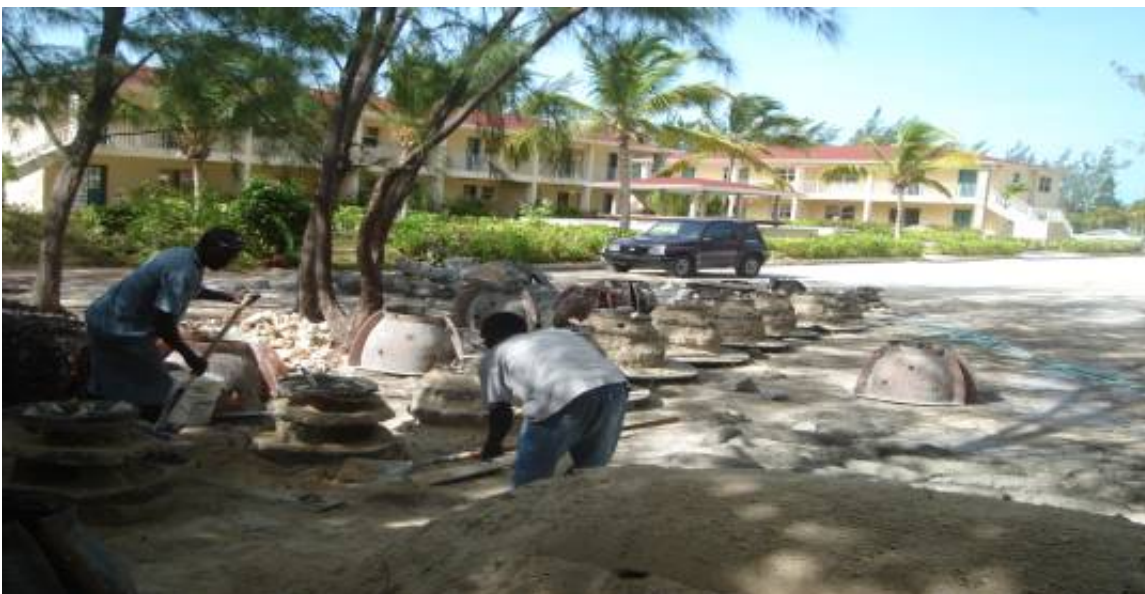
**Figure 3. Early fabrication stages.**

The reef modules were constructed July 22<sup>nd</sup> thru August 5<sup>th</sup> 2007 at the Treasure Beach lot located to the South of the hotel. The construction process was performed by 6 people, 3 persons from Reef Innovations, Inc. and 3 local laborers. Concrete and sand was purchased from Butterfield Concrete, forklift by a local contractor and shells and rock from local sources. Local coordination and transportation was provided by Beaches and expertly directed by Michael Clarke, the Water Sports Manager.

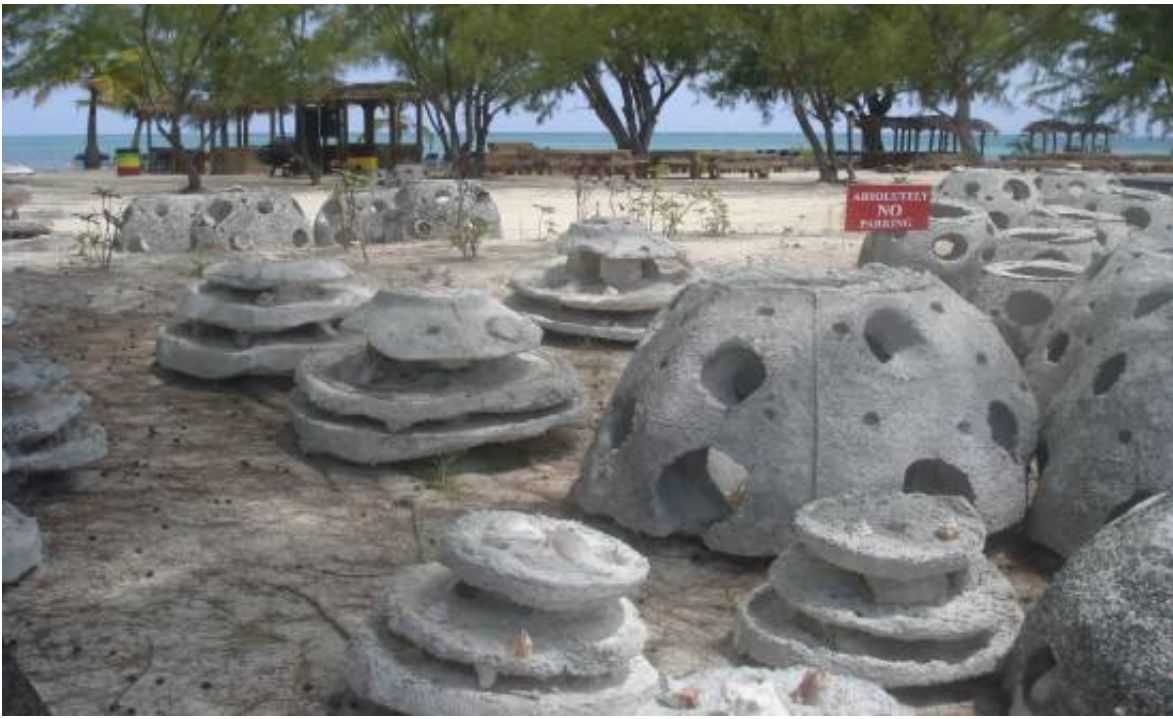
**Figure 4. Modules prior to deployment.**

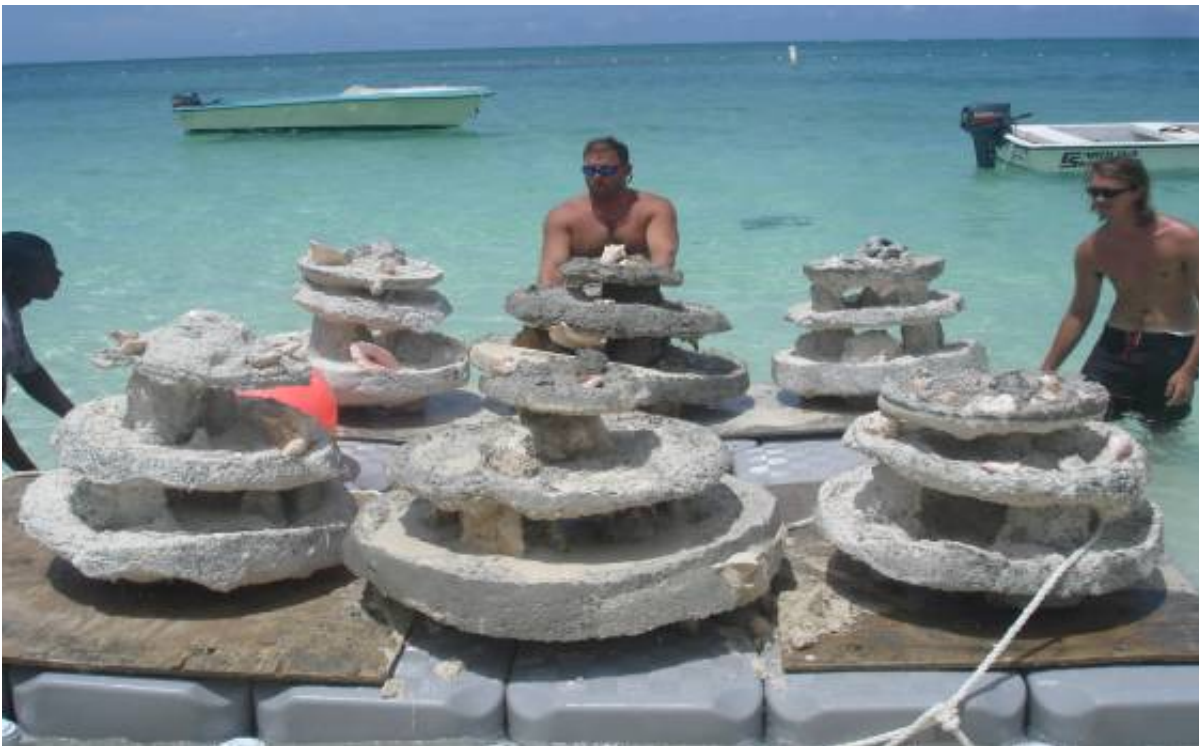
**Figure 5. Transporting modules to site.**

The fabricated units were deployed and transplants added the week of August 25-September 2, 2007. A total of 205 reef units were placed, with approximately 124 balls on the eastern site and 91 balls on the western site (5 balls were broken in process and counted as two). Of the 205 units, there were 20 pallet balls, 60 bay balls, 60 mini bay balls, 30 lo-pro balls, and 30 oyster balls with 50% of those being fabricated in the "layer cake" design.

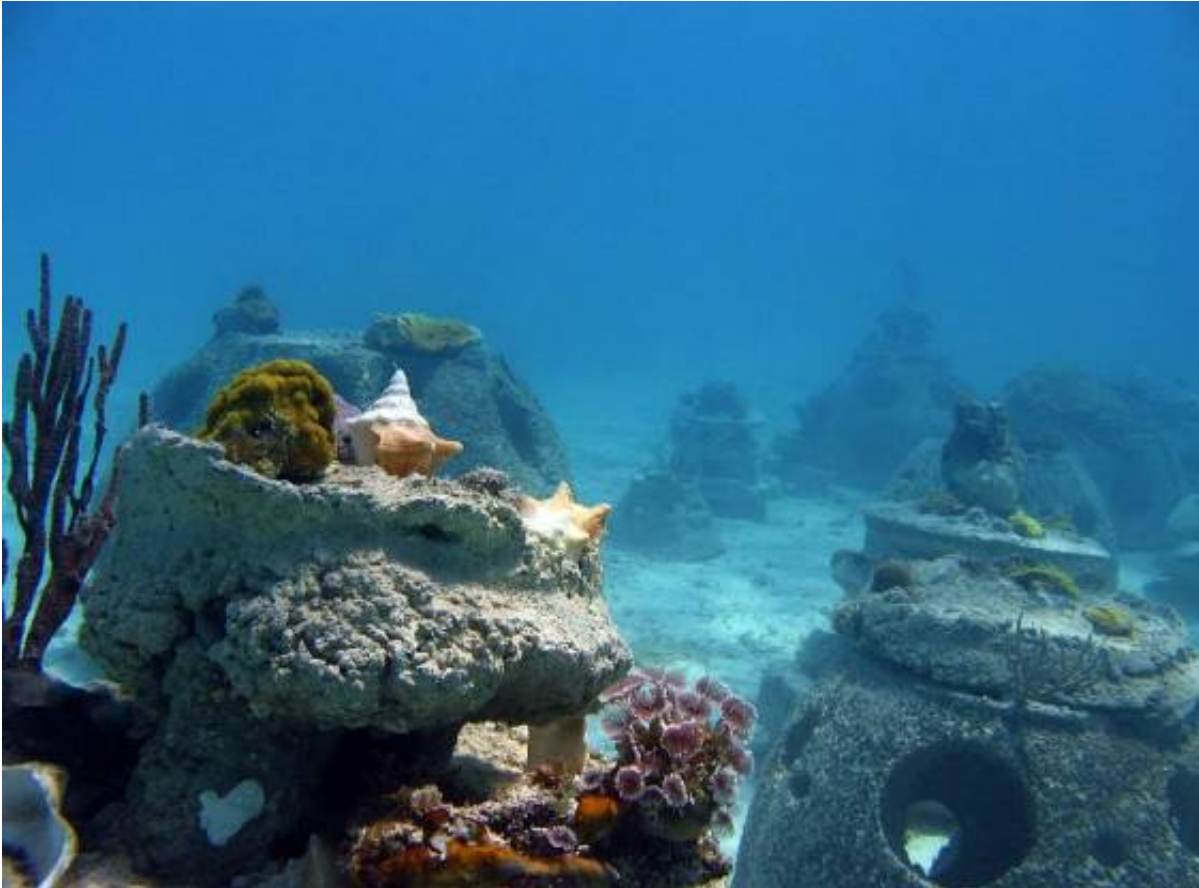
**Figure 6. An array with hard and soft corals and live rock.**

The coral transplants were taken from 2 different sites; the Third Turtle Beach Nourishment Project area and the sunken barge off of Water Cay. A total of 712 transplants were accomplished in the 7 day period, not including small corals (single finger corals divided from larger colonies) and red algal clumps (*Amphiroa* and *Neogoniolytho* spp.) that were added. The western site (Site 1) received a total of 314 hard corals, 27 soft corals, and 65 "live rocks" with associated invertebrates. The eastern site (Site 2) received 243 hard corals, 16 soft corals, and 47 "live rock" formations. All transplants have been photo-documented for further monitoring, and as of 1 week post construction, are all in good health. The following photos show examples of the work.

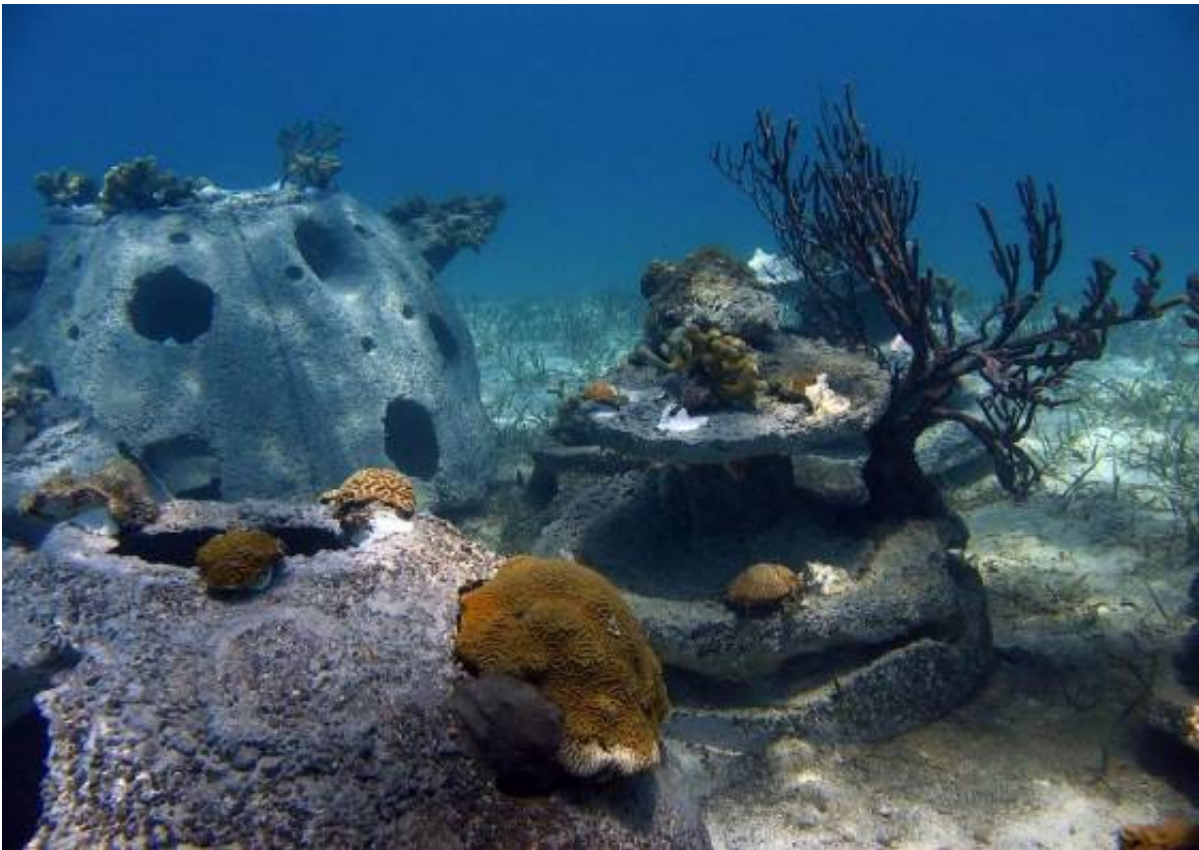
**Figure 7. More attachments of coral.**

. Two different techniques were used to attach the corals to the Reef Ball modules. The first utilizes a non-toxic type of putty that hardens within 24 hours. The second technique uses a special blend of Hydraulic cement which hardens within just a couple minutes. Utilizing the cement requires a team of people to mix, swim and apply, but is necessary for larger transplants that are not completely stable with surrounding water movements

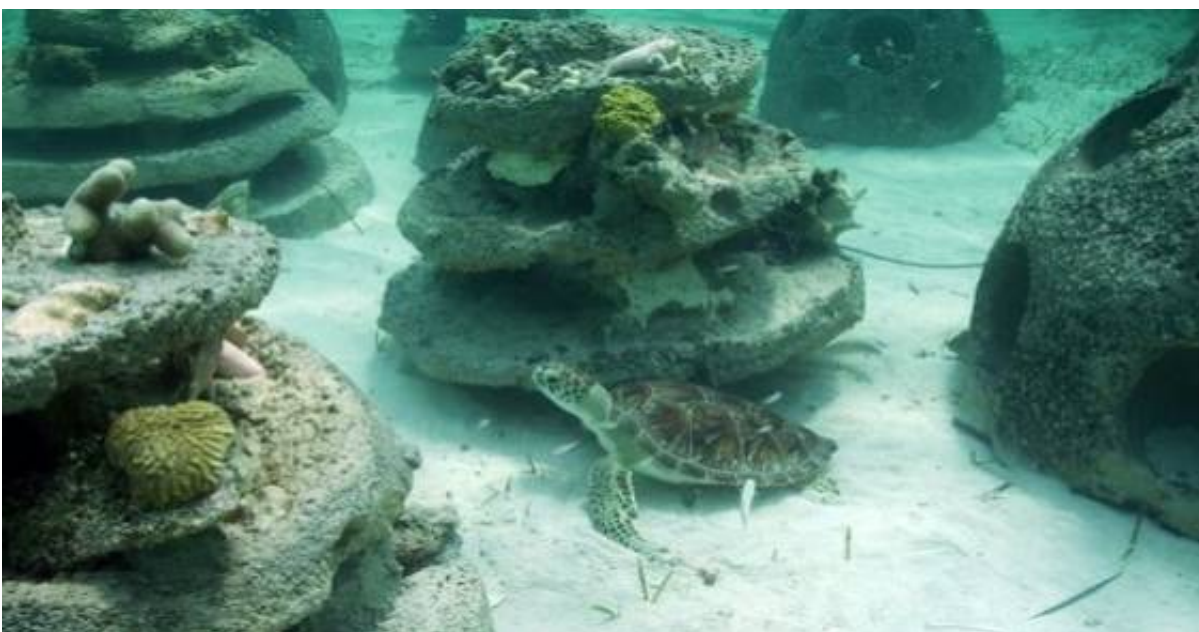
**Figure 8. Turtle on reef and anchoring cable through units.**

Anchoring of the units was accomplished by inserting Helical sand anchors at each pod, then attaching stainless steel cable that ran thru each of the reef structures. The cable was ran low on the units and buried in the sand as much as possible to be less visible. We intend to incorporate other anchoring techniques in future projects to better facilitate the aesthetics of the anchoring process.
