Figure 7. 5-Row Reef Ball Submerged Artificial Reef Breakwater offshore Grand Cayman

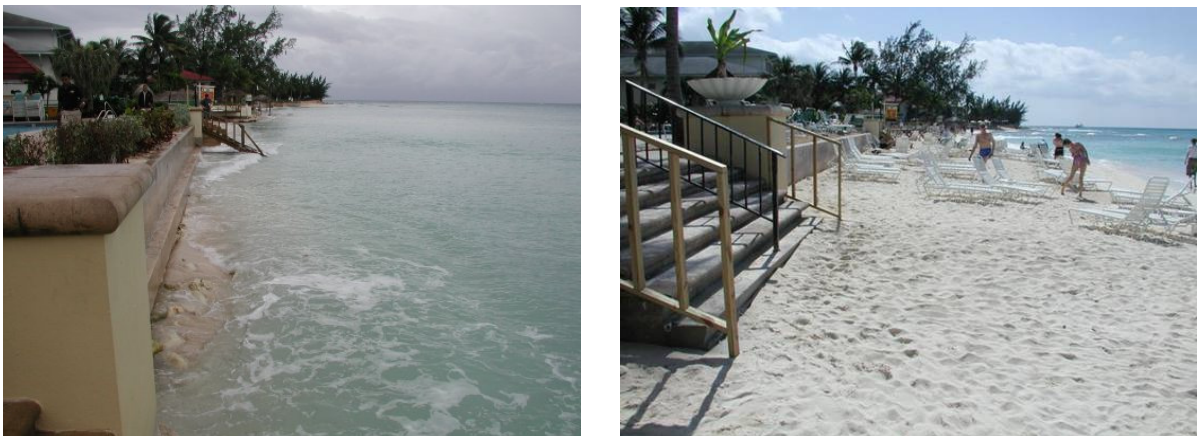
Figure 8. Marriott Beach Before (L) and After (R) Reef Ball Breakwater Installation

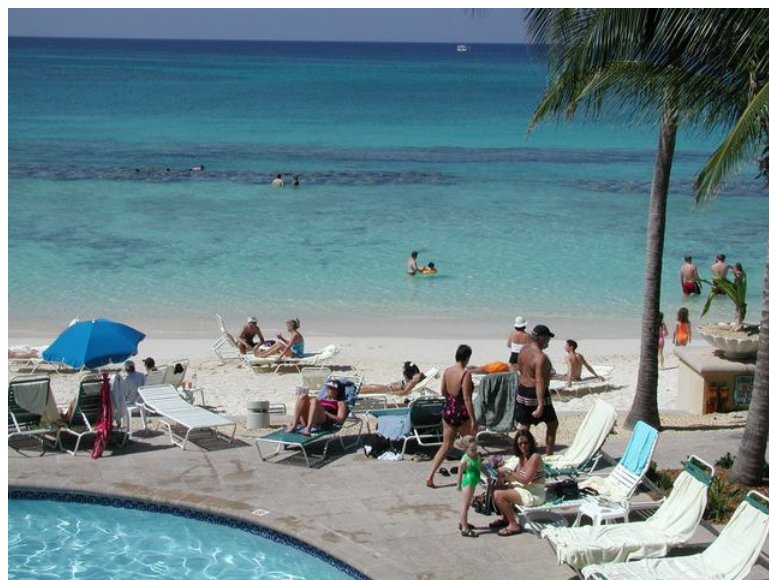
Figure 9. View of Reef Ball Reef offshore of the Grand Cayman Marriott
